Subject: 10CFR21 Reporting of Defects and Non-Compliance -  
Engine Systems, Inc. Report No. 10CFR21-0081

Refurbished Woodward EGB governor/actuators

**Report No. 10CFR21-0081**

COMPONENT: Refurbished Woodward EGB governor/actuators

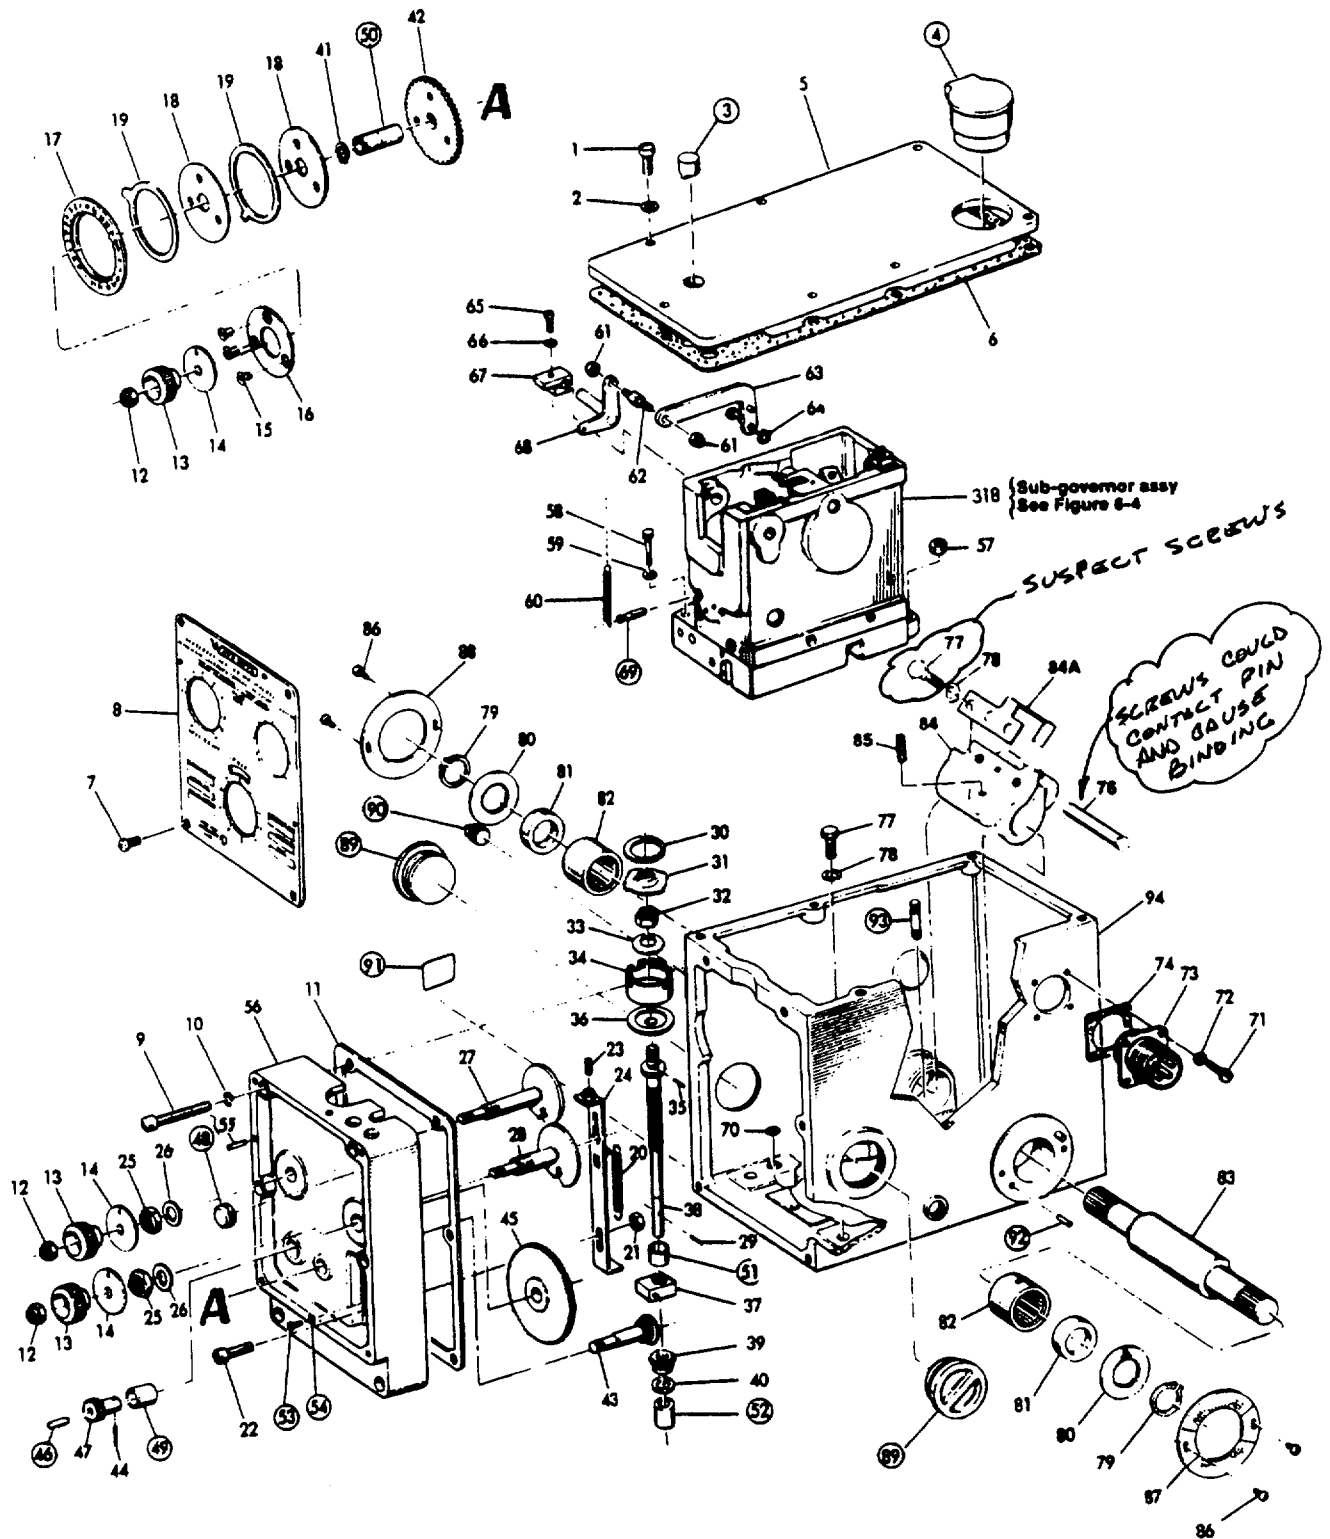
Figure 6-5. Column Assembly Parts for EGB-10P, 13P

Engine Systems Inc. (ESI) has received notification about a potential problem with some refurbished Woodward EGB governor actuators. One problem was recently reported by V.C. Summer Nuclear Station, via Power Reactor Event Number 37788. Apparently, a governor experienced binding of the terminal shaft due to incorrectly applied clamping screws. ESI was not notified about this occurrence until after the Event Report was issued; therefore, ESI was not able to verify/evaluate the actual components involved. Another problem was also reported by J.A. Fitzpatrick Nuclear Plant with this governor. Operability problems were observed and an investigation revealed that the droop lever pivot pin retaining rings were omitted during reassembly of the governor. Due to the missing retaining rings, the pins eventually backed out, releasing the droop lever. This caused the mechanical speed setting to drop and interfere with electric governor operation (limited load carrying capability). A parts breakdown for the EGB is provided in Exhibit 1 with the above parts annotated.

ESI recommends returning the suspect governors to ESI for a completed tear-down inspection. ESI will reassemble and functionally test to Woodward specifications. NOTE: Even though the V.C Summer governor screw length issue was corrected, we still recommend a complete tear-down to verify all refurbishment activity is within specifications. The Fitzpatrick unit (s/n 2185499) was recently returned to ESI to replace the missing terminal shaft retaining rings. A complete tear-down inspection was performed at that time; no further action on this governor is required. Contact ESI's Customer Service Department for return instructions.
